WASTEWATER AND HAZARDOUS WASTE SURVEY, ENGLAND AFB LA

January 1988

Final Report

USAF Occupational and Environmental Health Laboratory
Human Systems Division (APSC)
Keesler Air Force Base, Texas 78225-5001

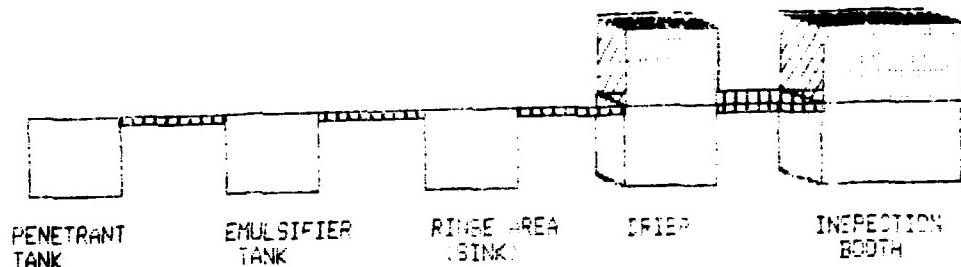
FIGURE 4. NDI PENETRANT INSPECTION SYSTEM

The penetrant inspection process (Figure 4) is an open system which uses a penetrant, emulsifier, and a rinse. Parts are sequentially dipped into the penetrant; removed; placed in the emulsifier; rinsed; and allowed to drip dry. The part is then sprayed with a developer and passed through a drying oven before inspection and final rinsing. The penetrant is changed every two years, drummed, and placed in the mixed oil waste tank at the NDI accumulation site. The emulsifier is changed every three years and drummed as a hazardous waste. However, the rinsed off emulsifier is discharged down the drain to the sanitary sewer system.

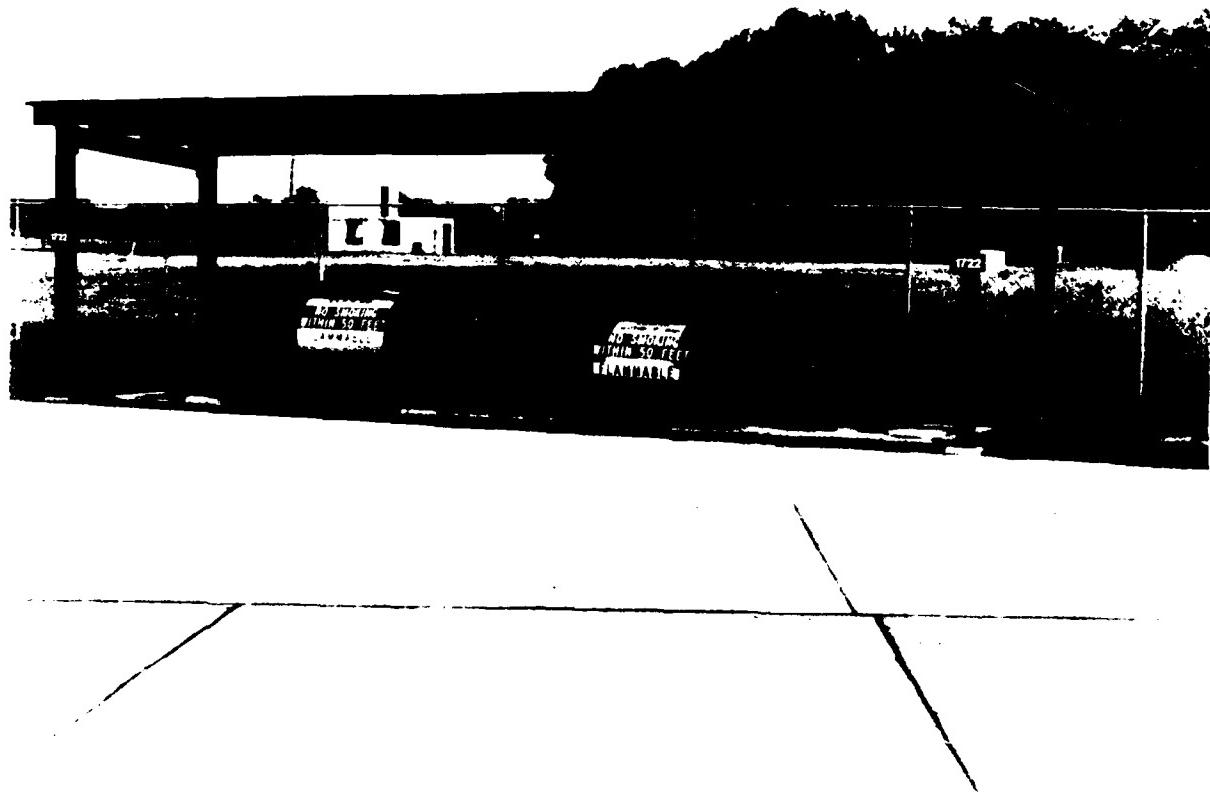
FIGURE 5. VEHICLE MAINTENANCE OIL STORAGE TANK

This shop is responsible for the maintenance and repair of base vehicles. Waste oil and transmission fluid are taken to storage tanks adjacent to the shop (hydraulic and mineral oil waste, 1000 and 250-gal capacities respectively--See Figure 5). A monthly log is kept on quantities generated. Tanks are pumped out once every 4 to 6 months. Waste fuel goes to the refueling maintenance accumulation site, bldg 2405. The bay area has three Safety Kleen degreasing units which are changed monthly. In addition, there is a Safety Kleen carburetor cleaning unit which is changed monthly. Waste antifreeze is discharged to the sanitary sewer. The Battery Shop handles about 10-15 waste batteries per month. Waste batteries are sealed in plastic and turned in to DRMO. However, if a battery is cracked (about one in every 30) the battery is neutralized with baking soda before turn in.

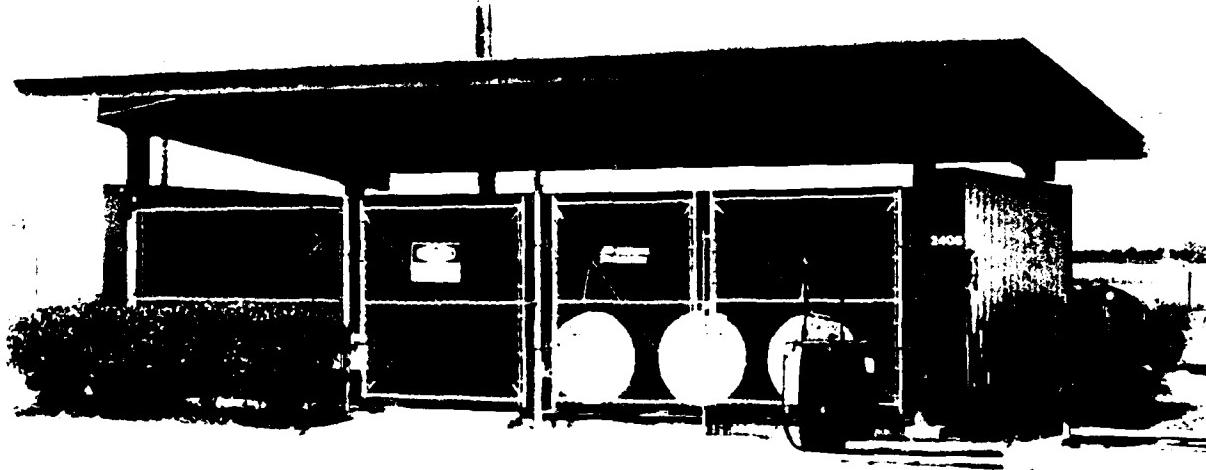
FIGURE 6. REFUELING MAINTENANCE ACCUMULATION SITE

Personnel perform all scheduled and unscheduled maintenance on all assigned refueling vehicles; to include repairs on both chassis and pumping systems. Waste generated is mainly petroleum products waste. Drained fuel is normally saved in barrels and returned to the system. Contaminated fuel is drummed as hazardous waste and stored at the shop's accumulation site, bldg 2405 (See Figure 6). Any fuel spilled during maintenance operations goes through the shop's oil/water separator before entering the sanitary sewer. Mr Tucker reports waste quantities to DEEV on a monthly basis. The shop is scheduled to use Safety Kleen in October 1987 for paint and thinner wastes.

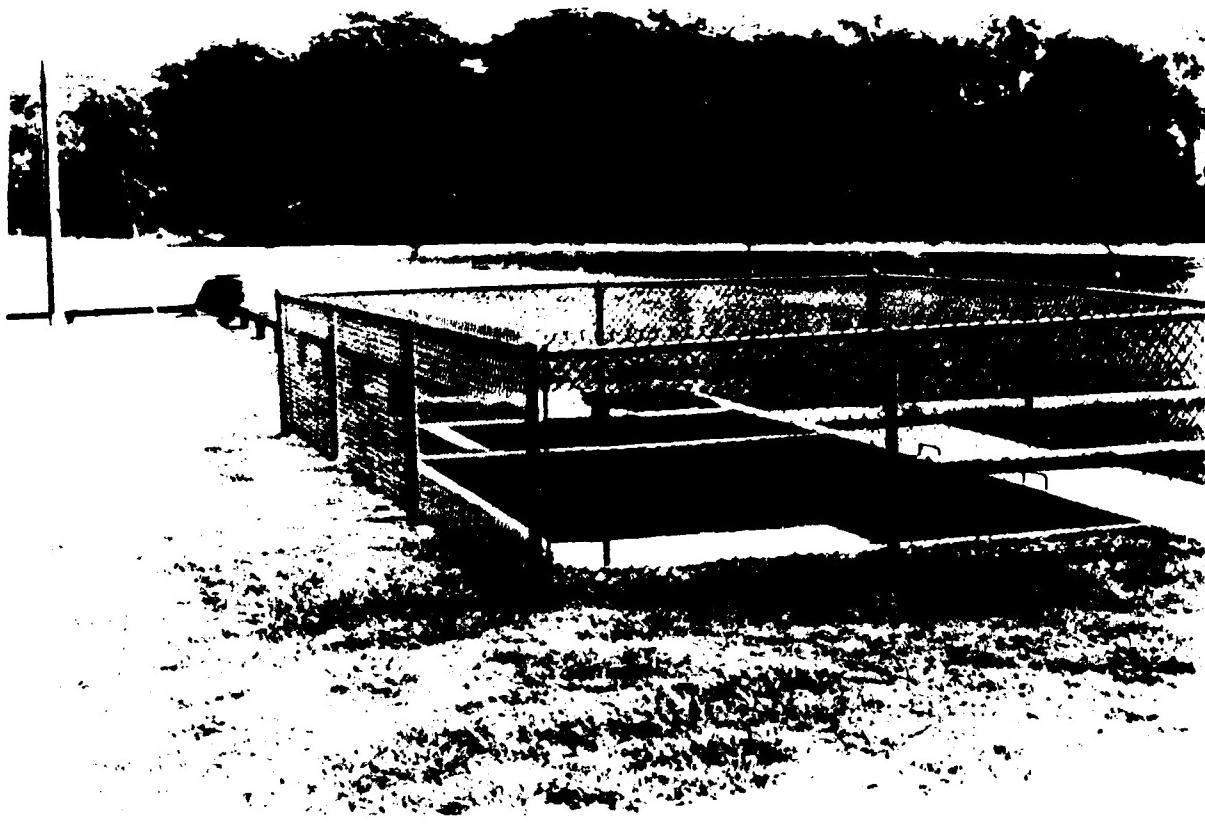
Figure 9: CORROSION CONTROL WASHRACK SEPARATOR

e. Stripping waste produced inside the shops is drummed and disposed of as hazardous waste. Rinsewater containing waste strippers from the Corrosion Control washrack passes through an oil/water separator before discharging into the sanitary sewer system.

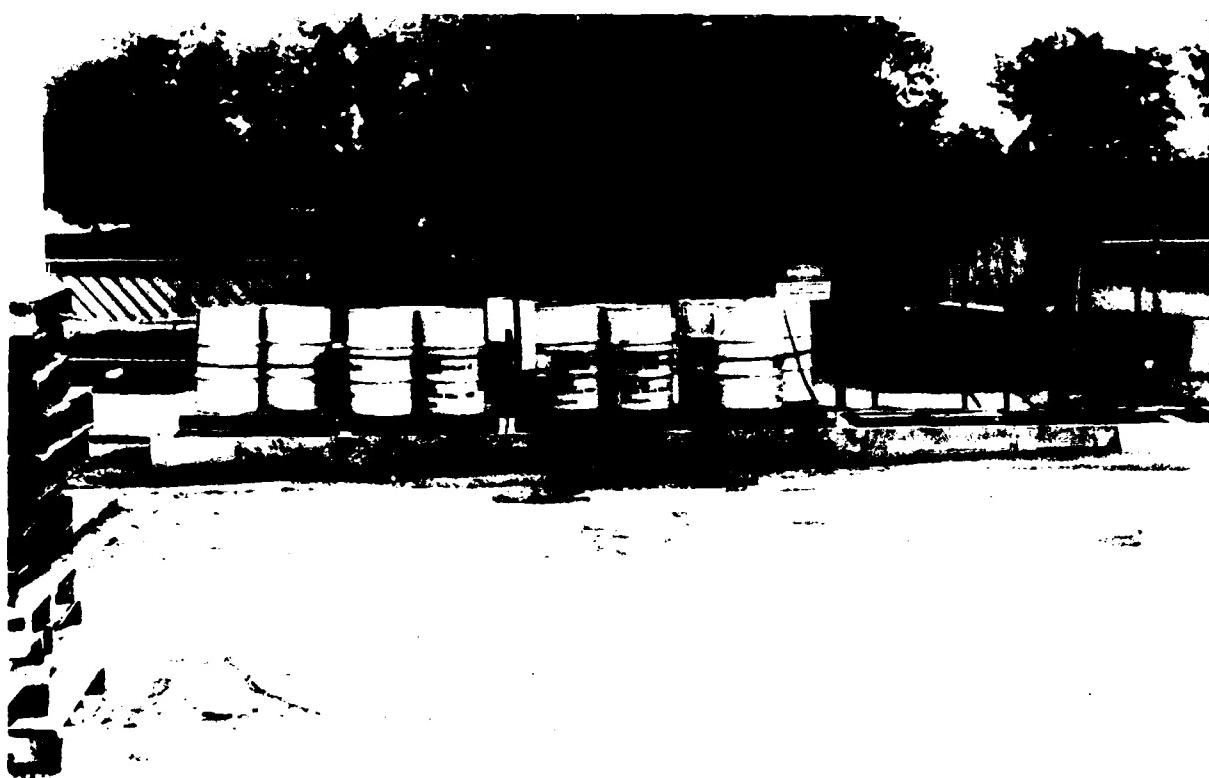
FIGURE 11. DRMO STORAGE SITE

15. The hazardous waste storage area at DRMO is presently inadequate (Figure 11). The area is not covered or secured. Rainwater causes the diked catch basin to overflow onto the surrounding pavement. According to Mr Cullough, these problems will be rectified when the base receives the pre-fabricated hazardous waste storage buildings in October 1987.
